Amarillo Air Terminal

Amarillo International Airport

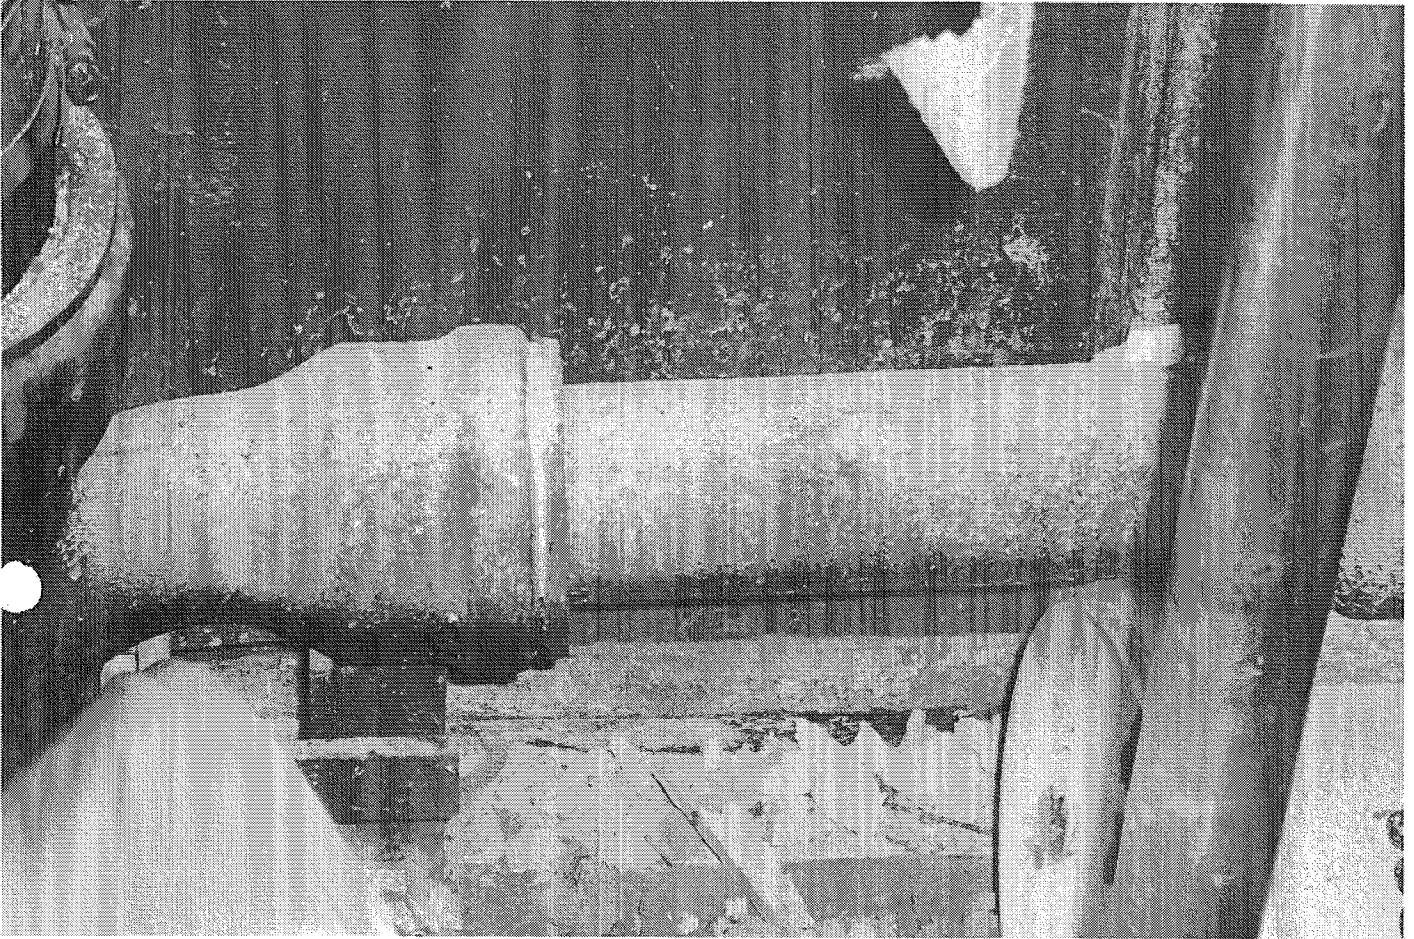
7. Annex 6th floor, adjacent to Womens RR - View of delaminated fireproofing dust and debris on iron pipe in wall (dust sample #2)

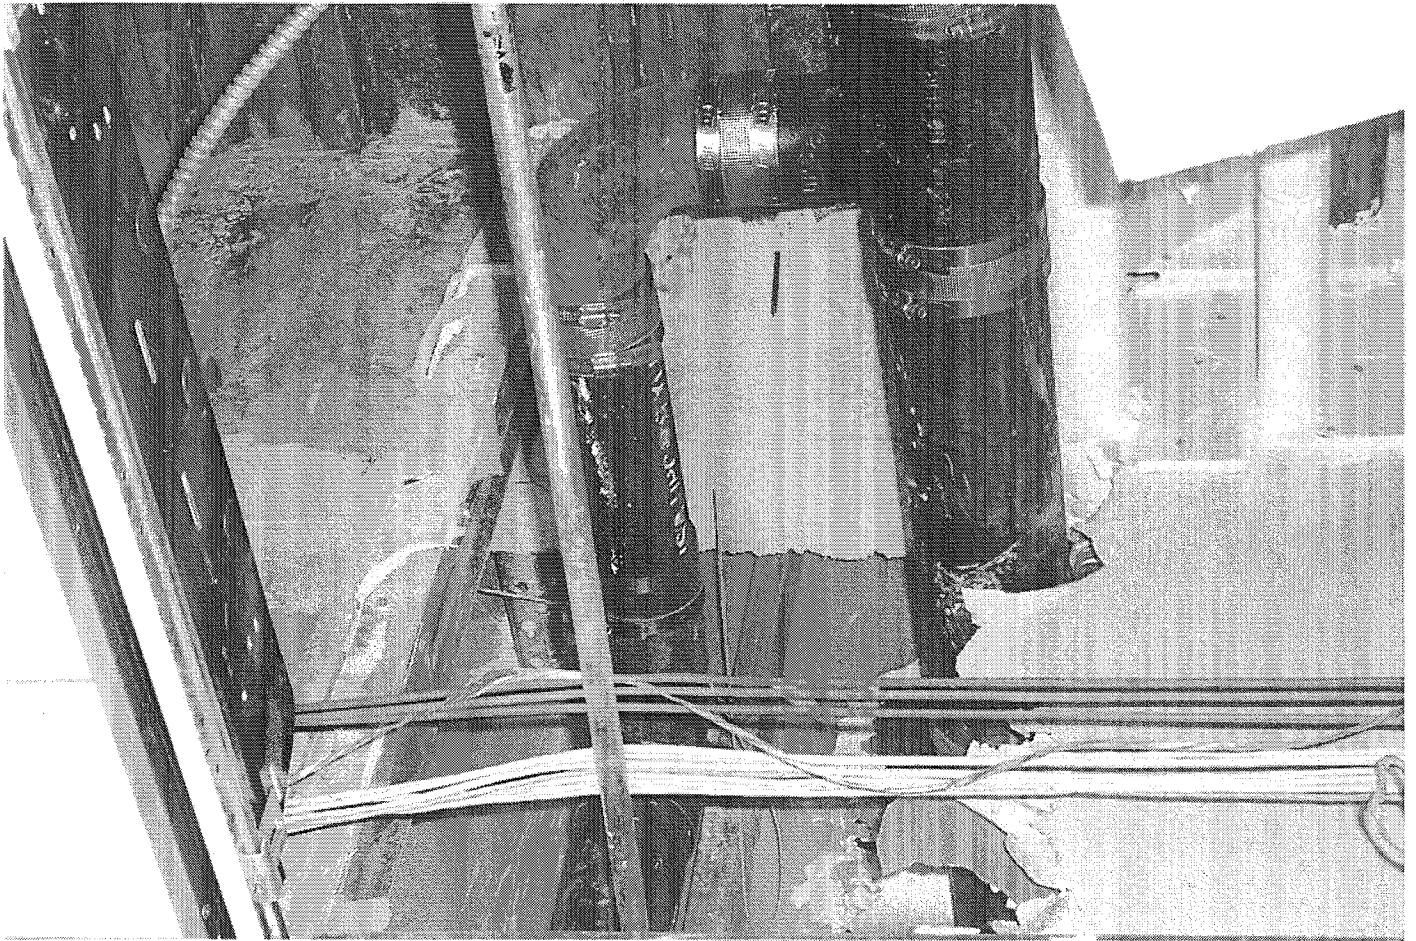
8. Annex 6th floor, adjacent to Womens RR - Close-up view of fireproofed beam above suspended ceiling and wall chase

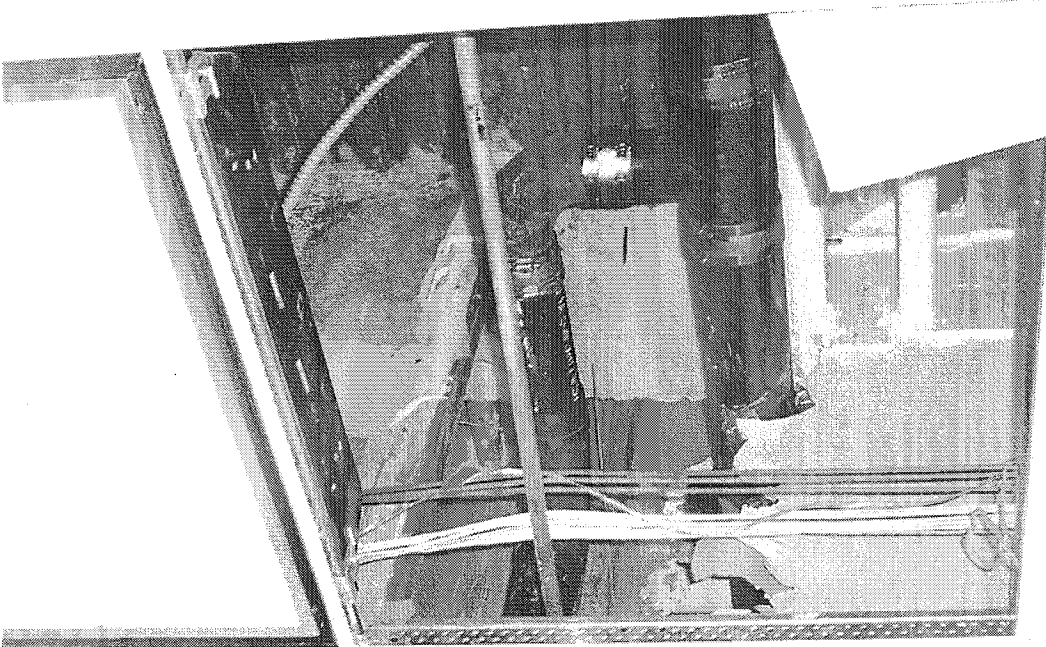
9. Annex 6th floor, adjacent to Womens RR - View of fireproofed beam above suspended ceiling and wall chase

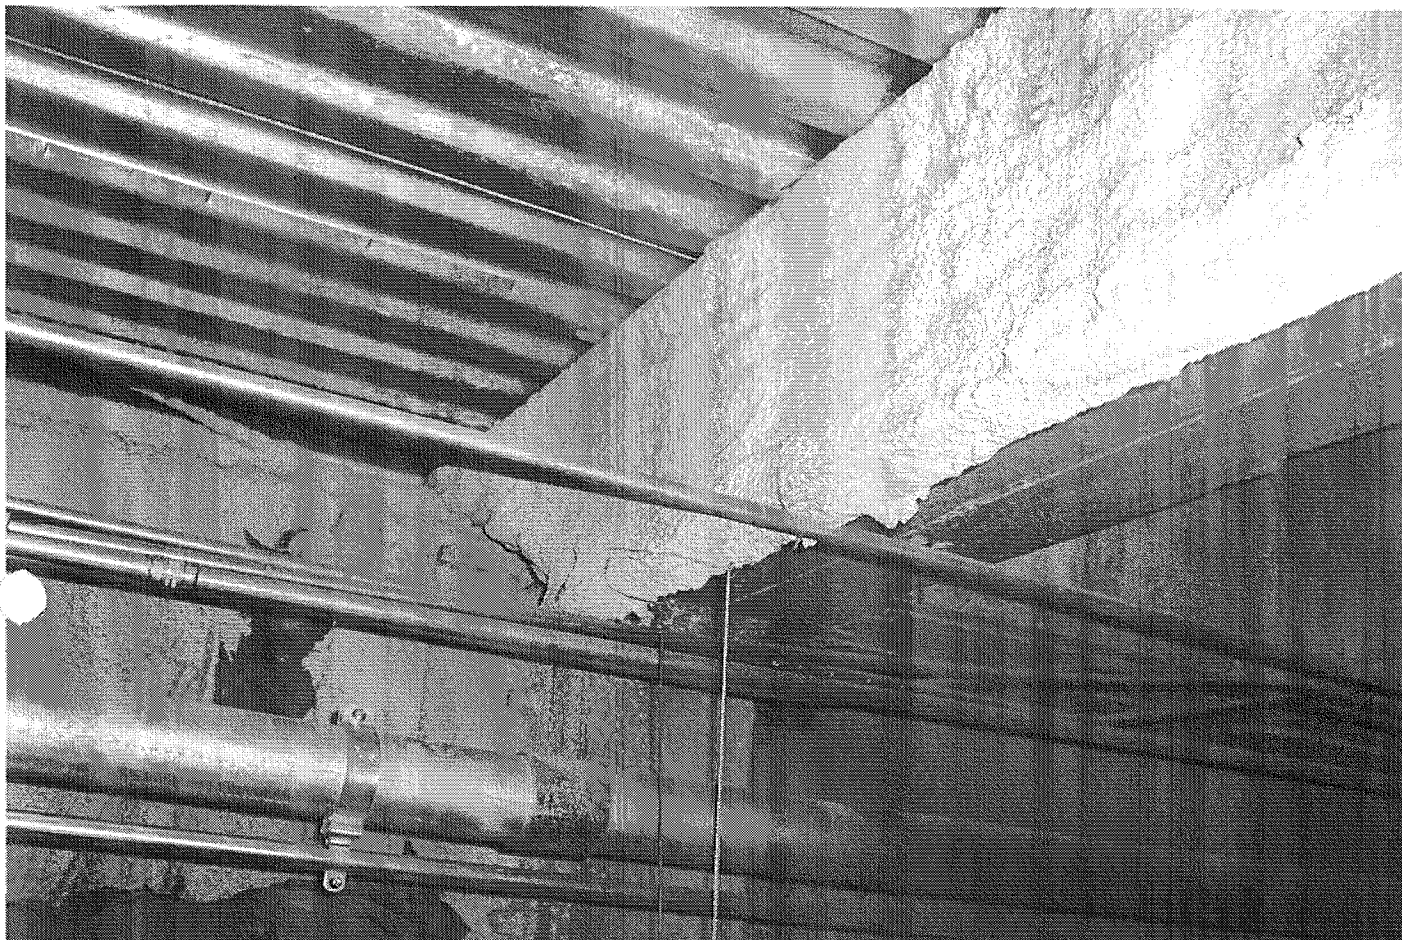
1. Concourse 30, 2nd floor, Airport Storage - General view of fireproofed beams and open web joists above suspended ceiling
